DEPARTMENT OF TRANSPORTATION

Quality Assurance and Source Inspection

Contract #: 04-0120F4Cty: SF/ALA Rte: 80 PM: 13.2/13.9File #: 69.28**WELDING INSPECTION REPORT****Resident Engineer:**Pursell, Gary**Address:** 333 Burma Road**City:** Oakland, CA 94607**Report No:** WIR-002189**Date Inspected:** 19-Apr-2008**Project Name:** SAS Superstructure**OSM Arrival Time:** 630**Prime Contractor:** American Bridge/Fluor Enterprises, a JV**OSM Departure Time:** 1730**Contractor:** Zhenhua Port Machinery Company, Ltd (ZPMC), Changxing Island **Location:** Shanghai, China

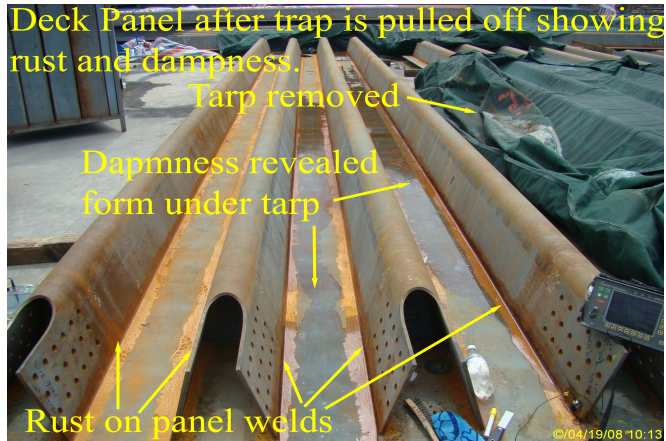
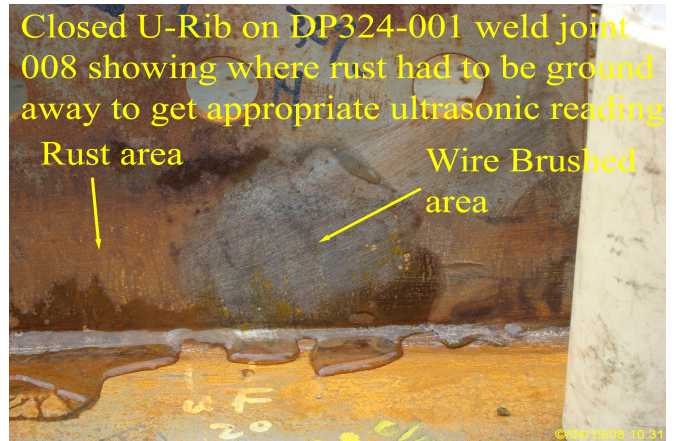
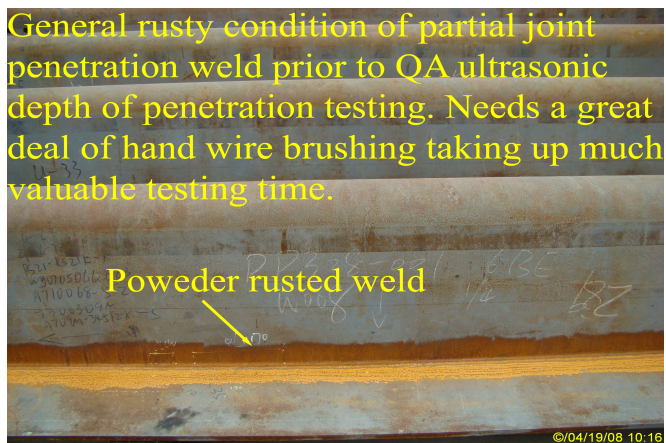
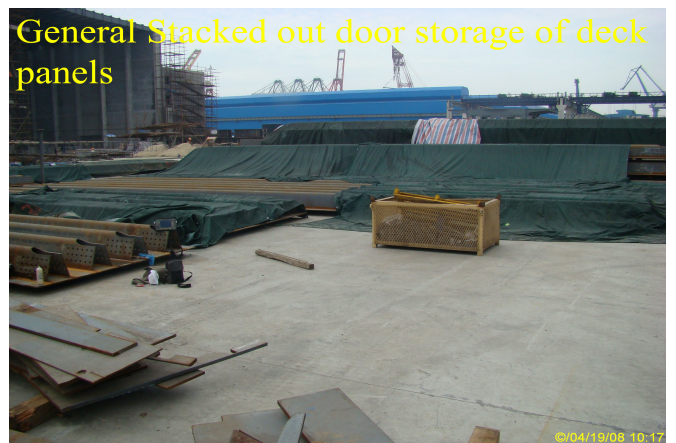
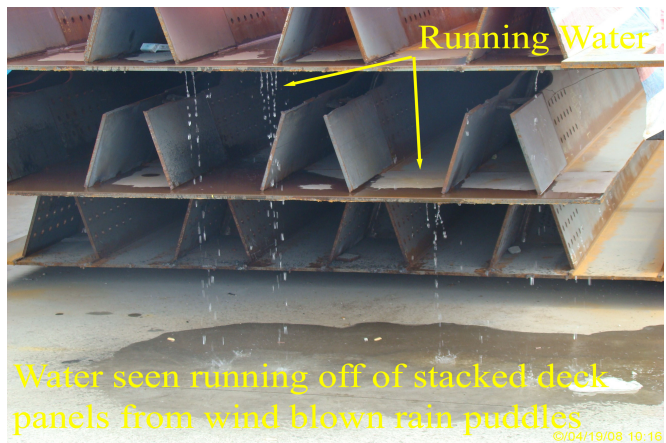
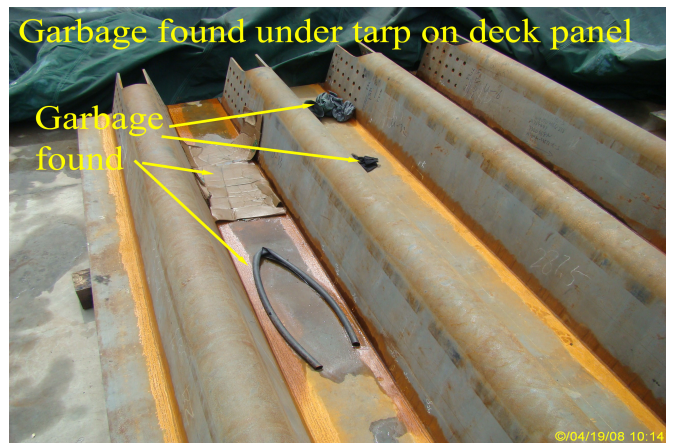
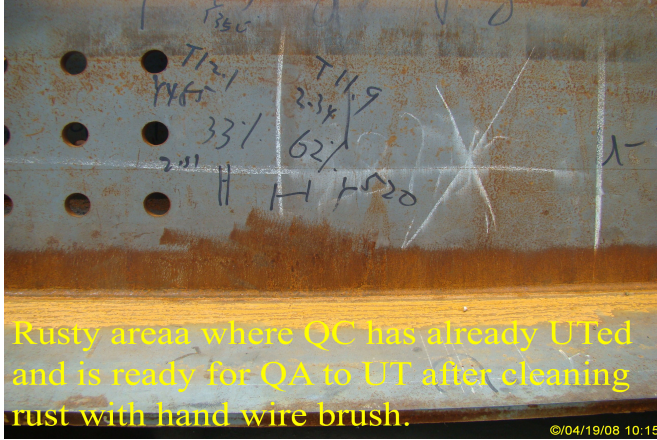
This Quality Assurance Inspector (QAI) observed the condition of the deck panels in the yard which still require quality assurance ultrasonic testing (UT) for depth of penetration (DOP) of the closed u-rib welds. In order for the QAI to perform the UT it required and extraordinary amount of hand wire brushing to bring the surface in to an acceptable state for scanning. When UT was performed over the powder rust on the previously polished area's it was found a 20% full screen height (FSH) signal would become a 35% FSH signal after removal of the powdered rust. The amount of cleaning time required was approximately three times longer than the inspection allowing for very little testing to be conducted. It appears that a power wire brush, battery operated, would be very beneficial in allowing more inspection time and less cleaning time. The deck panels have laid out in the weather and even when covered have had the polished area's rusted up.
